**CONSERVATION ASSESSMENT PROGRAM REPORT  
(Architectural Component)**

**Historical Society Museum and Library/Archives  
Agricultural & Industrial Museum  
Bonham House  
Colonial Complex  
Clarke Warehouse  
Fire Museum**

**YORK COUNTY HERITAGE TRUST**  
250 East Market Street  
York, Pennsylvania 17403  
<http://www.yorkheritage.org/>

March 1, 2014 (*Final*)

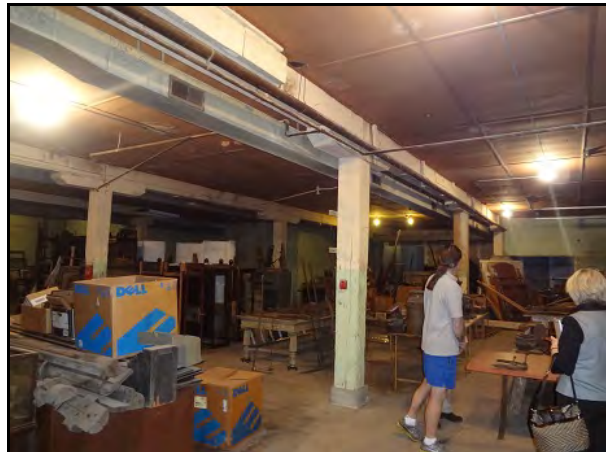
Fig. 14: view east in first floor of Clarke Warehouse

The Clarke Warehouse, located at 451 West Clarke Avenue, is a three-story, heavy-timber frame building with brick exterior walls on the first and second floor exterior walls, and wood framing with asbestos exterior siding on the third floor (see Fig. 13). The building was acquired by the Society in 1981 and it contains approximately 6,900 s.f of floor space per floor. The first and second floors are used for collection storage and the third floor is basically unused, except for recently stored items (see Fig. 14).

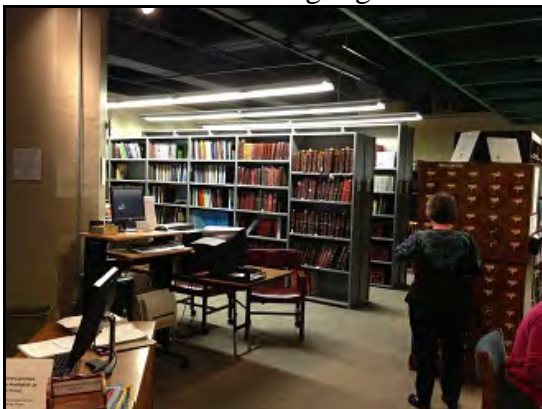
Fig. 21: view south in first floor stacks of Historical Society Museum and Library/Archives Building

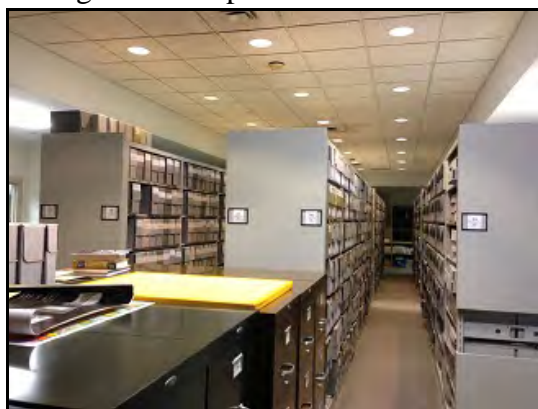
Fig. 22: view east at document shelves in Historical Society Museum and Library/Archives Building

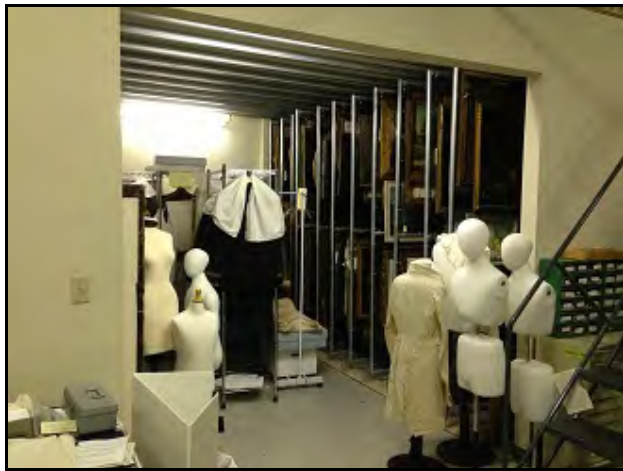
Available collection storage space is also inadequate in the Historical Society Museum and Library/Archives Building. Environmental concerns (mentioned above) notwithstanding, there is not enough space to properly store the Trust's collection. Even if a plan to deaccession redundant and unneeded objects within the collection were implemented, the size of the collection still greatly exceeds the amount of available space in the basement and second floor (see Figs. 23 and 24).

Fig. 23: view of costume storage space in second floor of Historical Society Museum and Library/Archives Building

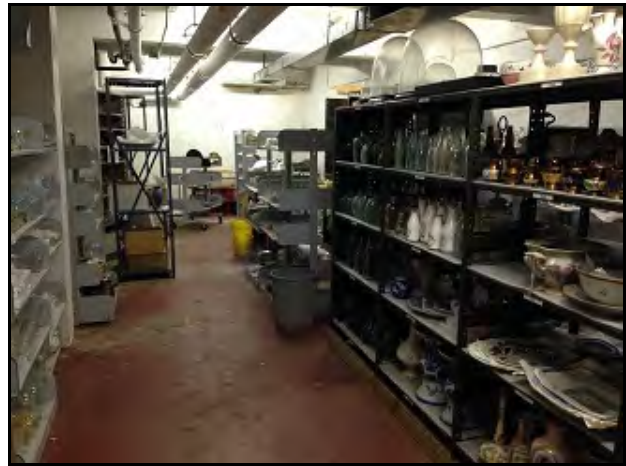
Fig. 24: view of collection storage area in Historical Society Museum and Library/Archives Building

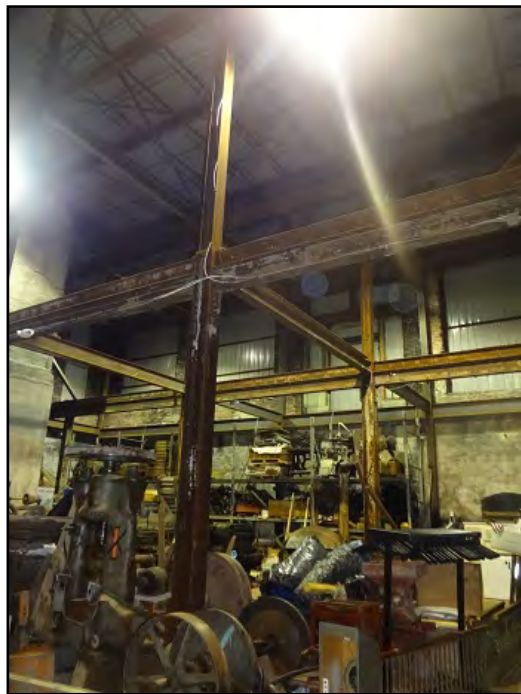
Fig. 27 (left): view looking east into open space known as F wing

Within AIM, F wing is an unused portion of the building, approximately 4,000 s.f., that is open and approximately three stories in height. This area has no environmental control at present, except for the conditioned air that enters from the adjacent first floor exhibit space (see Fig. 27).
