**CONSERVATION ASSESSMENT PROGRAM REPORT  
(Architectural Component)**

**Historical Society Museum and Library/Archives  
Agricultural & Industrial Museum  
Bonham House  
Colonial Complex  
Clarke Warehouse  
Fire Museum**

**YORK COUNTY HERITAGE TRUST**  
250 East Market Street  
York, Pennsylvania 17403  
<http://www.yorkheritage.org/>

March 1, 2014 (*Final*)

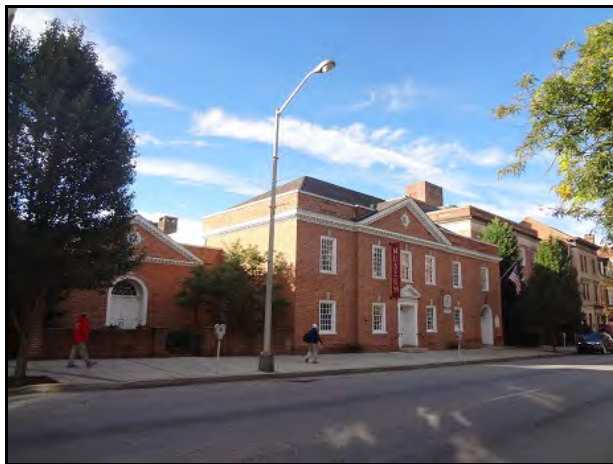
This impressive, former automobile showroom is two-story building that politely and respectfully fronts onto East Market Street. It is replete with Colonial Revival massing and details, including brick Flemish bond, projecting brick water table, brick flat arches over the double-hung windows, and a pedimented wood cornice above the second floor which contains a round, ocular window inset into the tympanum (see Fig. 1).

Fig. 1: north (front) elevation of the Historical Society Museum and Library/Archives Building (*all photos in this report by J. Bowie*)

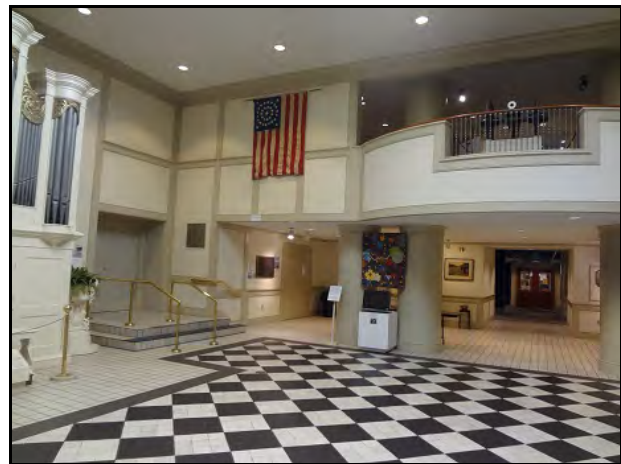
The architectural formality of the building’s front façade quickly gives way to the openness of the main lobby space as the visitor enters through the front doors. Here, the attributes of the former showroom were wisely maintained to give the visitor a glimpse of the size and impressiveness of the Trust’s (then the Society’s) collection. The two-story openness of the lobby space enables the visitor to look around and become quickly oriented to everything being offered. It also provides a well-organized place to greet visitors, and get them ready for their visit, whether it be for research or to tour the exhibits (or both) (see Fig. 2).

Fig. 2: view looking south in the two-story lobby of the Historical Society Museum and Library/Archives Building

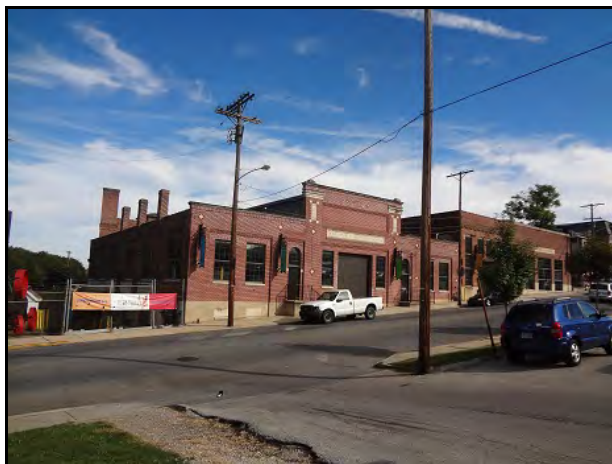
Fig. 3: south (front) elevation of the Agricultural & Industrial Museum (AIM)

In addition to the HVAC, at present, there are several other significant issues of concern at AIM. To begin, several of the roofs and flashing details are at (or beyond) the ends of their serviceable lives, and leaks have begun to occur. Likewise, spalling on the brick exterior walls facing into the courtyard and other areas has progressed in recent years, causing a noticeable loss of material and which exposes the inner (softer) portions of the brick to be exposed to weather – and hence to accelerated degradation. Also, during the building renovations, all the windows in the building were replaced with extruded, double-hung, thermo-pane units with limited UV film protection. At present, they permit drafts, and do not reduce UV or daylight infiltration.

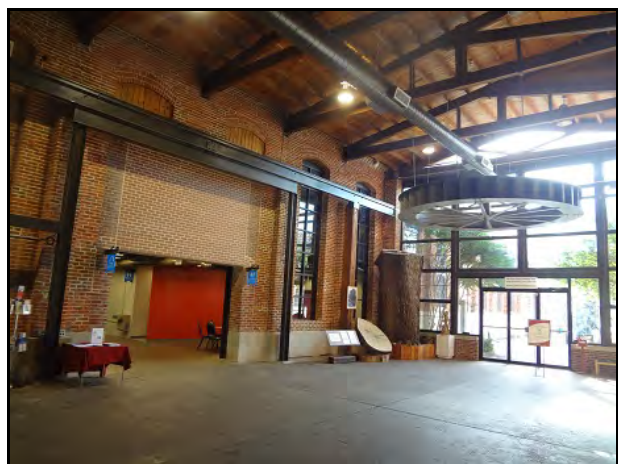
Fig. 4: view south in Main Lobby of AIM looking toward entrance doors and courtyard

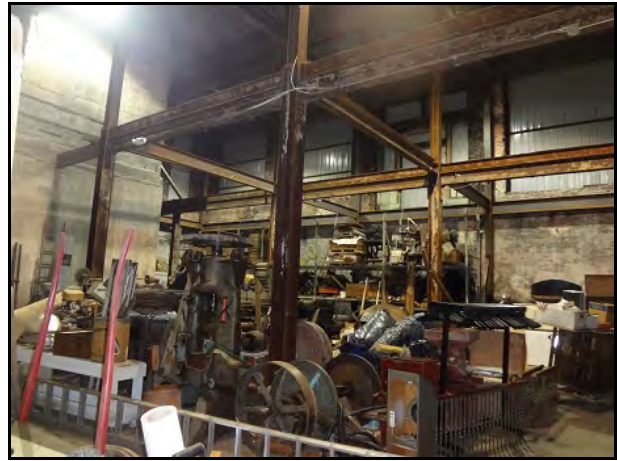
Fig. 6: detail east at F Wing in AIM

Within AIM, F wing is an unused portion of the building, approximately 4,000 s.f., that is open and approximately three stories in height. This area has no environmental control at present, except for the conditioned air that enters from the adjacent first floor exhibit space (see Fig. 27).

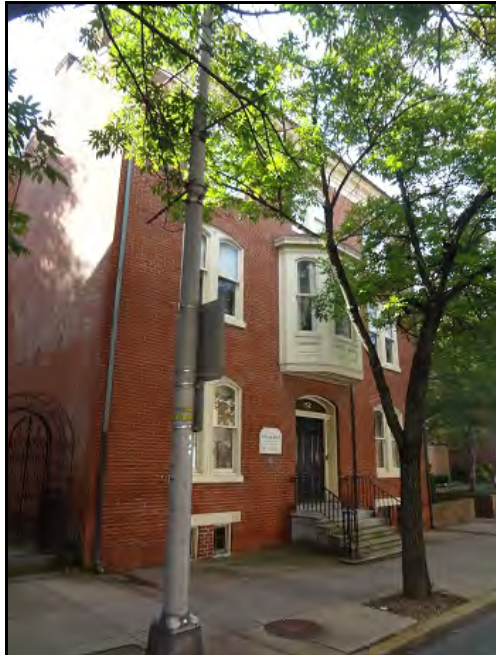
Fig. 7: north (front) elevation of the Bonham House

The Bonham House is open for visitation on Saturdays only in season, and it contains a gas-fired, forced hot-air heating system in only half the building. There is no summertime cooling, and no seasonal humidification or dehumidification. During the winter, the temperature is set at 50 degrees, F., and during the summer, there are no fans to circulate the air.

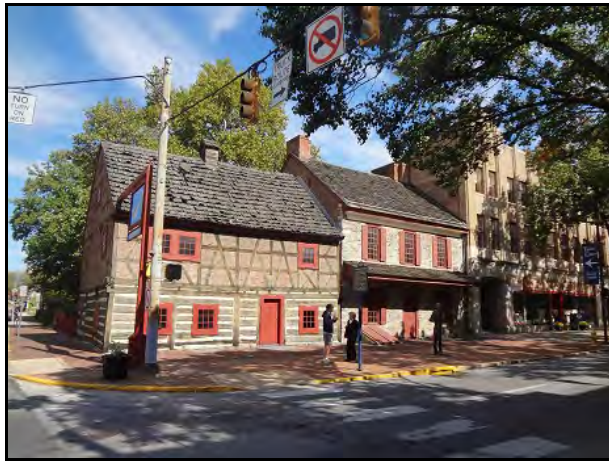
The Golden Plough Tavern is a restored two-story building with a stone foundation, exposed log first floor, and a half-timber second floor, infilled with pointed brick. The roof contains double-taper side-lapped wood shingles. On the interior, the logs and chinking are exposed on the walls, and the second floor framing is also exposed. On the second floor, the wood half-timbering is exposed, but the brick contains a plaster skim coat and the walls in their entirety are whitewashed. In some locations on the interior, the original lath, plaster and brick infill remain intact and are carefully protected with clear acrylic sheets. The attic contains the original heavy-timber wood framing with knee braces, purlins, collars and rafters. It is lit and can be seen through an acrylic panel positioned in the second floor ceiling. The building has a stone basement that floods during extremely heavy rains.

In the walls of both Gates and Plough is ductwork from the previous commercial use in the 1960s. There is also a boiler in the attic of the summer kitchen and an air handler in the basement; both are abandoned in place.

Fig. 9: south (front) elevations of the Golden Plough Tavern (left, at corner) and General Gates House (right) and 1920s-era commercial building at right

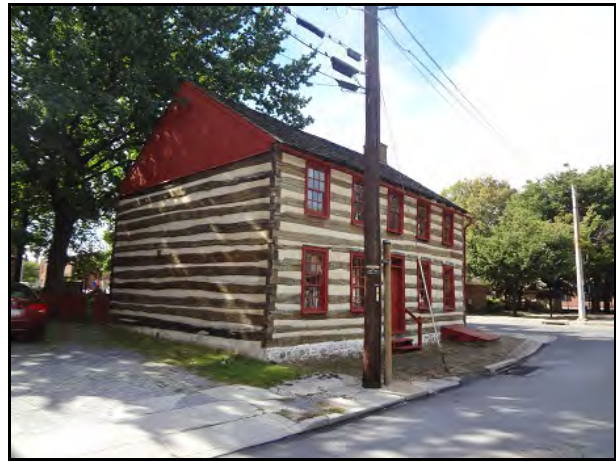
Fig. 10: north and east elevations of the Barnett Bobb Log House in northeast corner of Colonial Complex

The Barnett Bobb Log House is situated in the northwest corner of the Colonial Complex. It was relocated to the site and restored in the 1970s. It is small, two-story building with exposed logs and chinking set on a stone foundation, and a gable wood shingle roof (see Fig. 10). On the interior, the logs and chinking are exposed and whitewashed along with the exposed second floor joists and flooring. Metal brackets have been installed where the second floor joists were at one time pocketed into the logs; they provide supplemental support. The second floor is an unfinished space, with a single wood collar at the eave, which prevents the long walls from spreading. Otherwise, there are no attic joists – it is an open space.

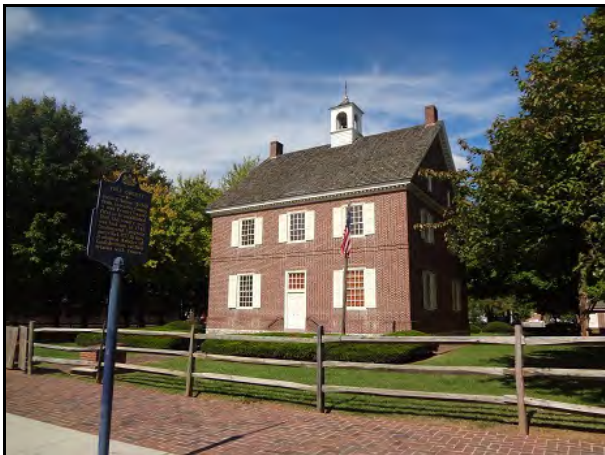
The Colonial Courthouse was reconstructed in 1976; it is a two-story brick building with a wood shingle gable roof, brick end chimneys and a wood cupola in the center. The exterior is laid up in the Flemish Bond, and contains shallow brick arches on top of the panel-shuttered, wood double-hung windows and doors. A slightly projecting brick string course articulates the line between the first and second floors, and a projecting wood dentil cornice defines the eaves and rakes at the roof line (see Fig. 11 – next page).

The roof and geothermal heating/cooling system were recently installed, and the cupola was recently repaired; however, the building has no additional humidification and dehumidification systems for the collection pieces, including the Lady Justice statue, clock and bench – all of which came from the original court house.

Fig. 11: south elevation of Colonial Court House directly west of N. Pershing Avenue in the Colonial Complex

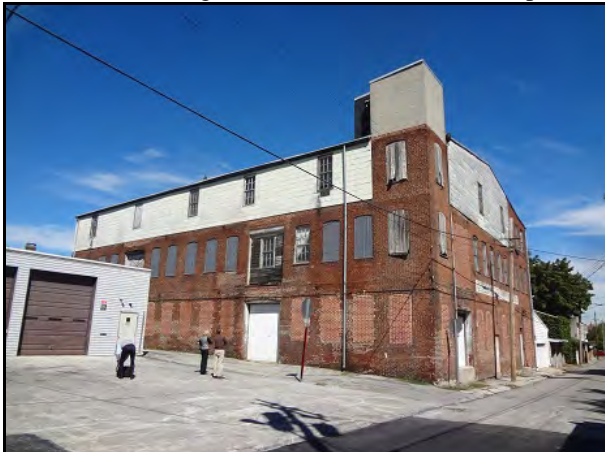
Fig. 13: south and west elevations of Clarke Warehouse

The Clarke Warehouse, located at 451 West Clarke Avenue, is a three-story, heavy-timber frame building with brick exterior walls on the first and second floor exterior walls, and wood framing with asbestos exterior siding on the third floor (see Fig. 13). The building was acquired by the Society in 1981 and it contains approximately 6,900 s.f of floor space per floor. The first and second floors are used for collection storage and the third floor is basically unused, except for recently stored items (see Fig. 14).

The building has no heating, cooling or any ventilation. It has no humidification or dehumidification, and it has no plumbing. It contains a 200 Amp main electrical distribution panel and a combination of Romex and EMT wiring and a combination of incandescent and fluorescent lights. Since it was constructed as a warehouse, the timber framing is capable of supporting a fairly high dead load; however, the interior elevator has not been maintained in over 20 years. Further, since it contains no HVAC, and since the building has no integrated pest management (IPM) plan, the Clarke Warehouse does not present itself as a viable collection storage option.

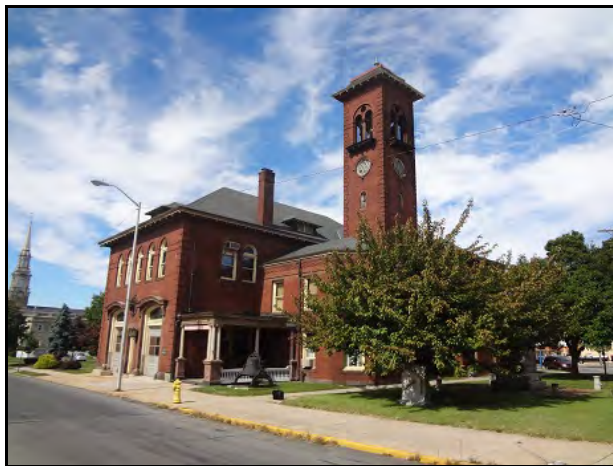
Fig. 15: east and south elevations of Fire Museum

The Facilities Report for the building, prepared by NuTec Design Associates in 2006 determined that the building contains numerous deficiencies relating to general accessibility, the HVAC system, plumbing system, electrical systems, lighting, alarms, general weathertightness and integrity of architectural materials, surfaces and finishes. Their report opined that the cost of implementing the recommended upgrades, repairs and replacements would be over \$1,300,000 (in 2006 dollars).

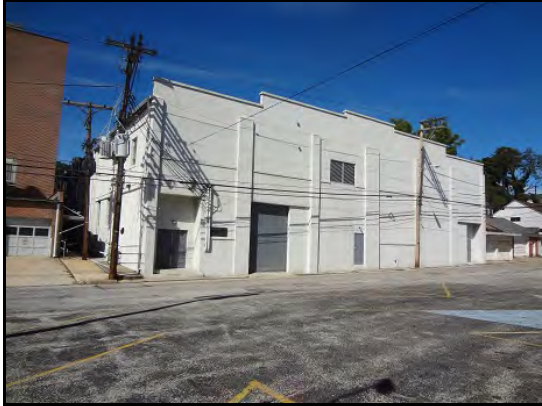
Parking is also an issue that affects not only the buildings themselves, but the ability of staff to conveniently and safely travel between them for routine activities and periodic inspections. At the Historical Society Museum and Library/Archives Building, there is metered street parking and a city parking garage 1-1/2 blocks away. There are several spaces behind the Baker Building with another 50 southeast of the rear alley (see Fig. 19). All of those spaces are currently owned by the Trust. Should the Baker Building sell, most will convey although plans to keep 20 spaces are in place. At AIM, there are 10 spaces across West Princess Street, adjacent to the high school parking lot. During off-hours, the high school lot is also available for parking. However, this is not a permanent situation (see Fig. 20). Simultaneous events at the school and AIM present a parking challenge for the public.

Fig. 19: south (rear) elevation of the Historical Society Museum building. Several parking spaces are currently available at the rear of the Baker Building (the brick Building to the left in the photo)

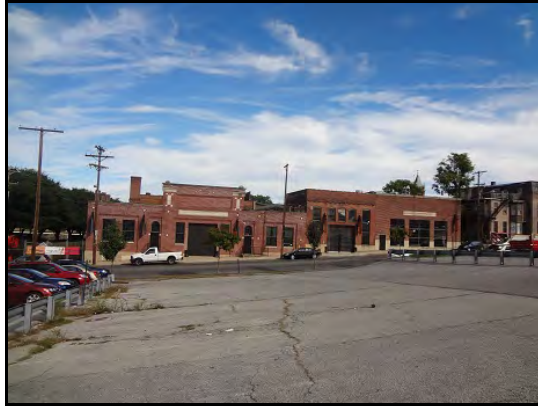
Fig. 20: long view of south (front) elevation of AIM taken from the high school parking lot; there are 10 spaces for AIM at the left side of the photo (behind the guard rail)

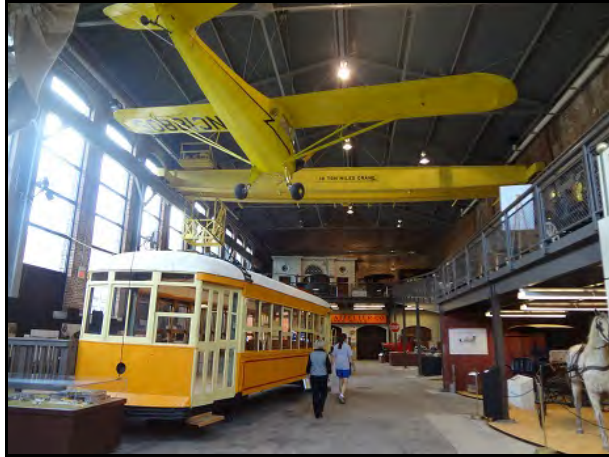
The AIM is well-suited for the exhibition of its collection. It is a large, sprawling former industrial building with several two-story spaces where large objects such as airplanes, recycled grist mill building/hurst frames, pumping engines, water wheels, turbines, cranes and agricultural vehicles can be displayed and the visitor can view them from a distance (to see their grandeur) before coming up for closer inspection (see Fig. 25 – next page). However, the drawback, as was mentioned earlier in this report, is the lack of temperature and relative humidity control, and the lack of daylight/ultraviolet control. The larger objects are affected by temperature and humidity changes that cause condensation and expansion/contraction on surfaces, which promote rust and deterioration. The smaller objects are even more sensitive to temperature and humidity

Fig. 25 (above, left): detail of large objects on exhibit at AIM
